# MT DNRC Response to Musselshell Flood 2011

## River Assessment Triage Team (RATT) Site Report

### Site: Randy Frost

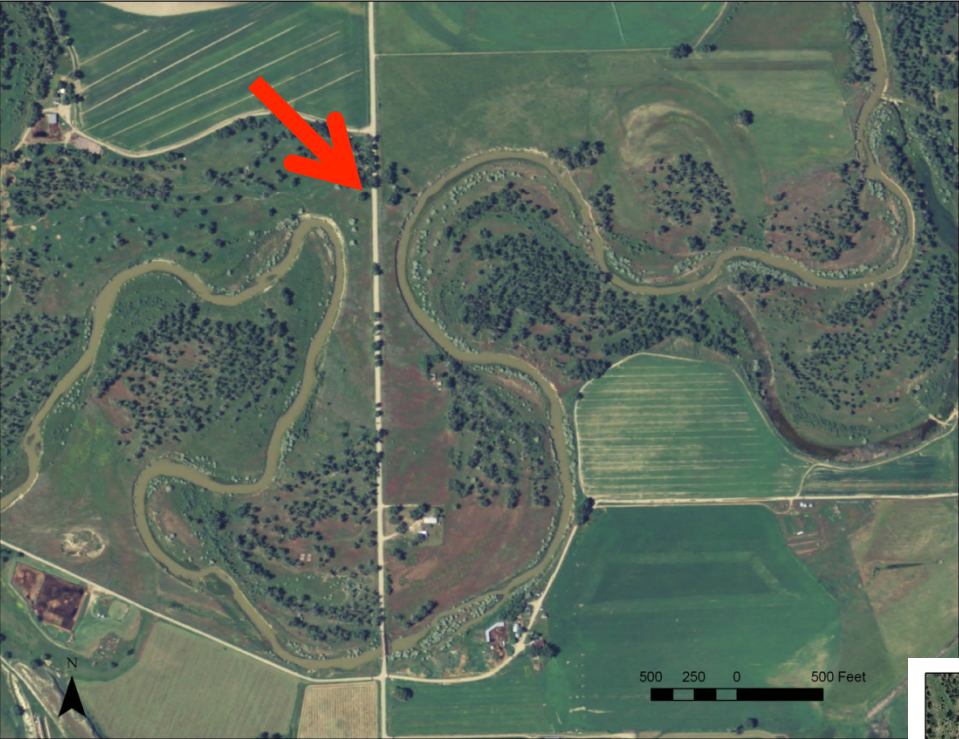
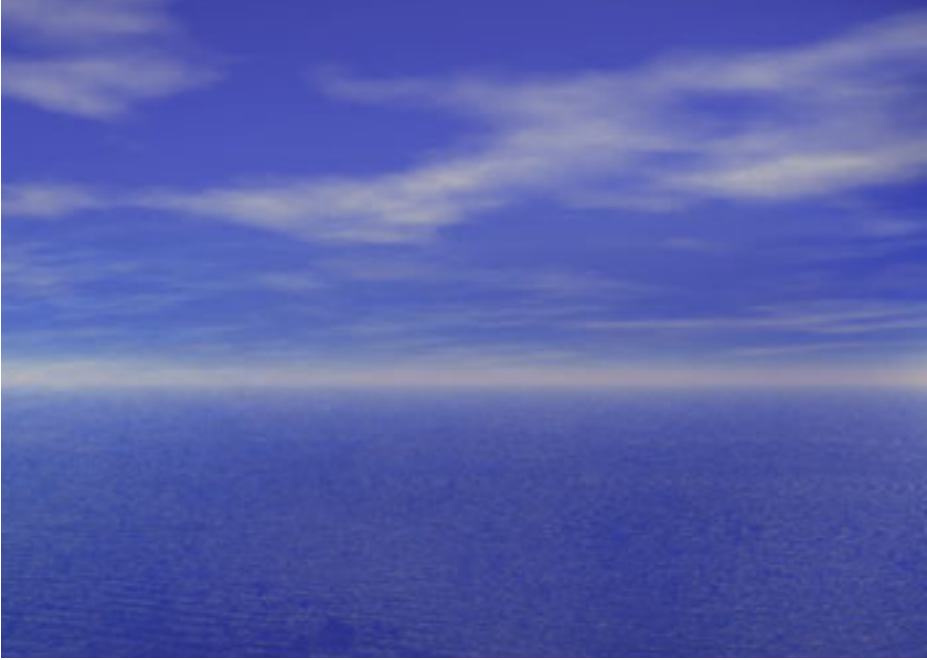
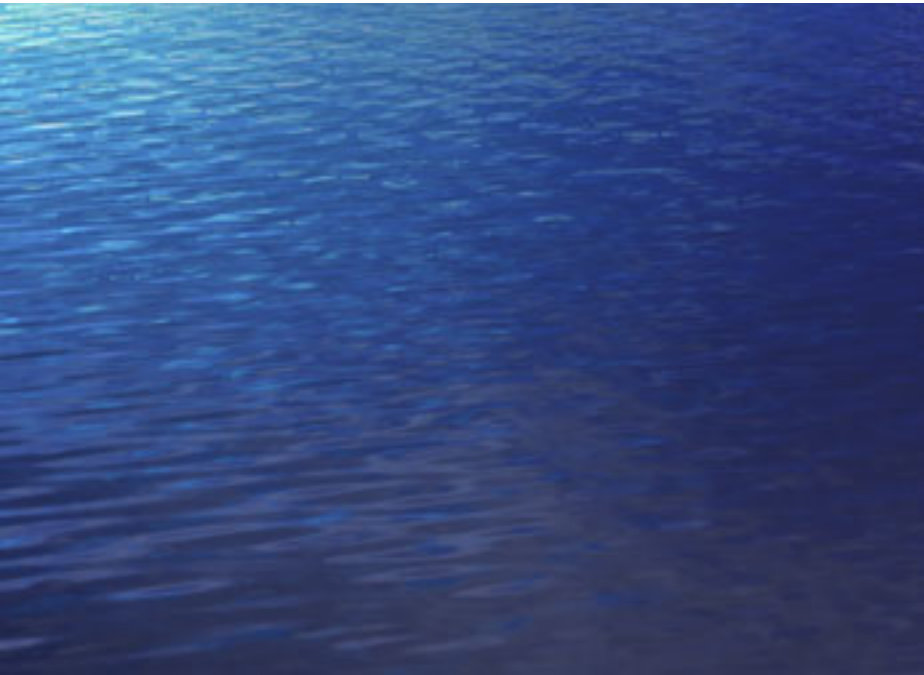
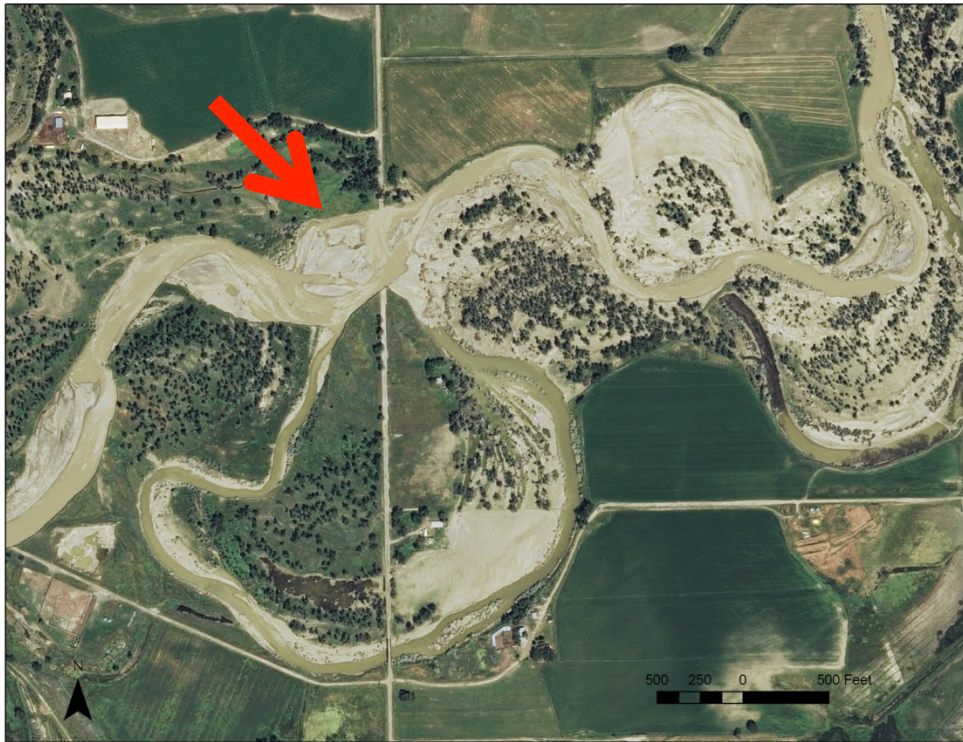
## **Avulsions & Meander Cutoffs**

**The Lower Half (170 miles) of the Musselshell River Lost 24 Miles of River Channel through Avulsions and Meander Cutoffs. This Equates to about 14% of it's Length through this Reach of the River**

**Avulsion - An Abrupt Change in the Course of a Stream that Forms the Boundary between Two Parcels of Land Resulting in the Loss of Part of the Land of One Landowner and a Consequent Increase in the Land of Another**

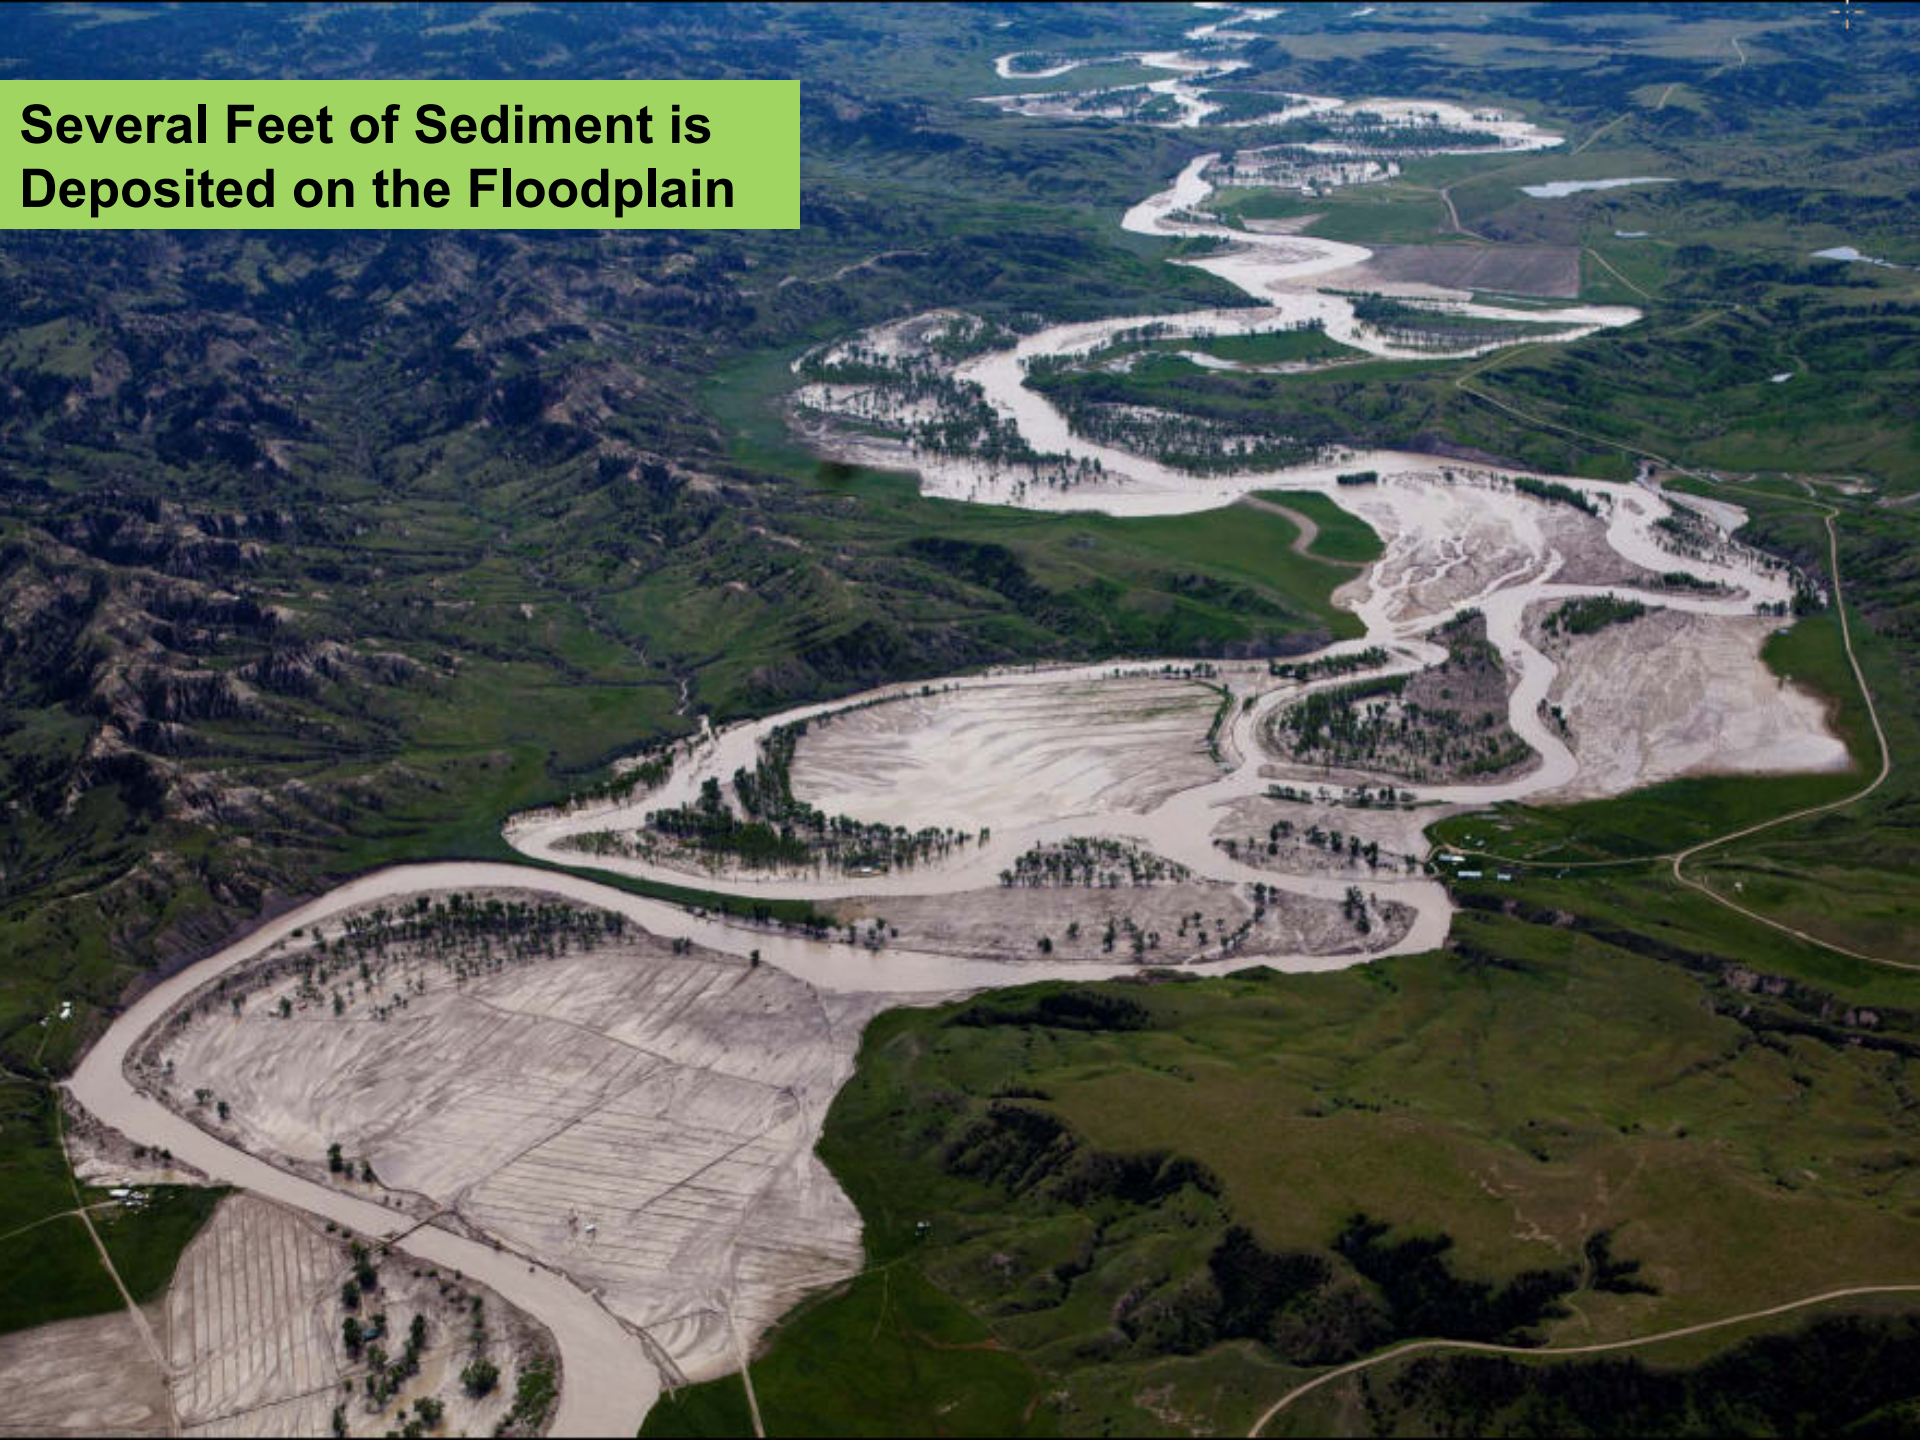
**Crop Land Lost to Production  
from Scour of Failed  
Avulsions & Cutoffs**

**Several Feet of Sediment is  
Deposited on the Floodplain**

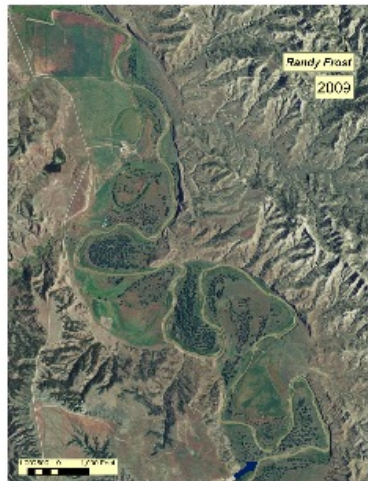
Figure 1. Pre-flood (2009) air photo of sites.

Flood impacts to this area of the Lower Musselshell River include avulsions (carving of new channels), lost pump sites, severe bank erosion, channel widening, massive sediment deposition on the floodplain, and hillslope failure (Figure 1 and Figure 2). An old cabin was destroyed by an avulsion, and a water line was washed out. Three sites are described in this report, including one pump site abandoned by an avulsion, one pump site eroded out, and a buried field (Figure 2).

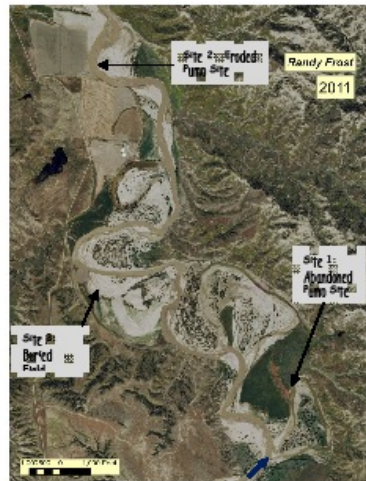
Figure 2. Post-flood (August 2011) air photo of sites

The third site is an area of massive sediment deposition on a previously sprinkler irrigated field (Figure 2). A sediment probe indicated at least 4 feet of deposition in some areas. Because of the depth of the new sediment, it is not feasible to till it into the old field soil, and probably too expensive to remove with normal means. There are broad carpets of cottonwood and riparian seedlings in the new sediment. The best opportunity in this area may be to place this area into a USDA program designed to protect the seedlings and encourage their growth over at least the next several years while providing incentive payments to off-set some lost production.

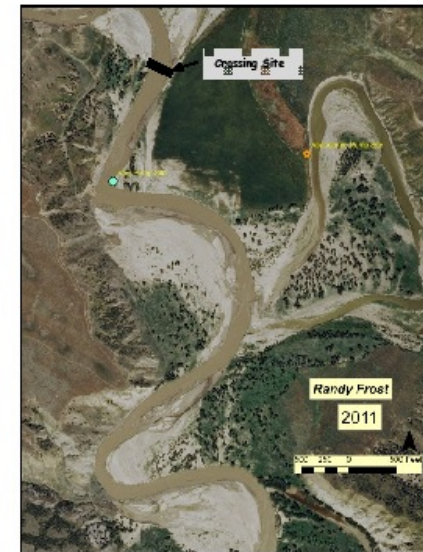
Figure 3. 2011 air photo showing abandoned pump and recommended new pump site, Site 1.

Site 1 consists of a pump site that was abandoned due to an avulsion cut off a large bendway (figure 3). Nearly 1.5 miles of river channel were lost. Discussions at the site focused on the identification of a new pump site to irrigate fields east of the river. A good site was identified along the left valley wall bluff line near a power line crossing. The site should be relatively stable against the valley wall, but it will be important to locate the inlet of a portable pump in relatively deep water through the bend. A ford river crossing to access this field will also need to be constructed downstream of the proposed pump site.

At Sites 1 and 2, we recommend that the pump sites be relocated as described above. Moving the pumps to a new location is a change in Point of Diversion (POD). This has implications for water rights; the DNRC Water Rights Bureau in Lewistown should be contracted prior to any work to determine how water rights issues should be addressed. It may be optimal for the new portable pumps to be filed as a "transitory" POD to allow them to be moved as necessary within a designated reach of river.

Site 1 will also require a river ford crossing to access the fields east of the river. Shape the banks to allow equipment access and transport in pit run gravel to harden the river bottom crossing as necessary.

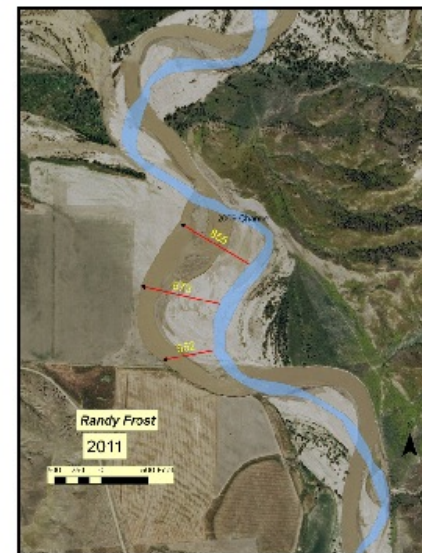
Figure 5. 2009 channel (blue) showing migration distances in feet.

Site 2 consists of a long section of left bank erosion that eroded out a pump site and exposed sections of buried mainline pipe. It is located on a large bendway that eroded over 800 feet toward the west during the flood, destroying approximately 37.5 acres of field (Figure 5). The bank is approximately 15 feet high, and is on the edge of an irrigated field. The bank is unstable, and will continue to collapse and slope back with time. There is portable floating pump available at the site. The best option at this site appears to be excavation of an access ramp down through the high bank to gain river access for the floating pump. The ramp should be low gradient and fairly wide to accommodate future slumping of the riverbank and walls of the ramp.

The irrigated field that was eroded now extends to the river's edge (Figure 5). The bank will continue to adjust in response to the flood, so more bankline will likely be lost due to either mass failure (slumping) or bank erosion. It is important that a buffer be established between the actively irrigated ground and the bank edge, to prevent oversaturation and to minimize additional slumping of the bank.

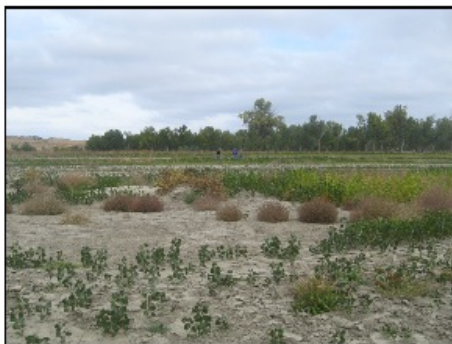
Figure 8. Cottonwood seedlings at Site 3.

The 2011 flood deposited sediment on fields, in old cottonwood stands, as new gravel bars, and in abandoned channels, in some cases making them difficult to irrigate or use productively. In many of these areas, thousands of young cottonwood and willow seedlings have taken root. This flood event has created a tremendous opportunity to develop a young class of riparian vegetation in the river corridor that will help to stabilize the system in the long-term. In order to encourage the protection of these areas to increase the odds of survival of the young trees, the USDA has developed several program options for riparian area protection (Flood Recovery Initiative Programs). Additional programs are available to help restore fields damaged by the flooding. If producers are interested in these programs, they should contact the local USDA office (FSA and NRCS) for program eligibility criteria, participation requirements, and financial benefits.

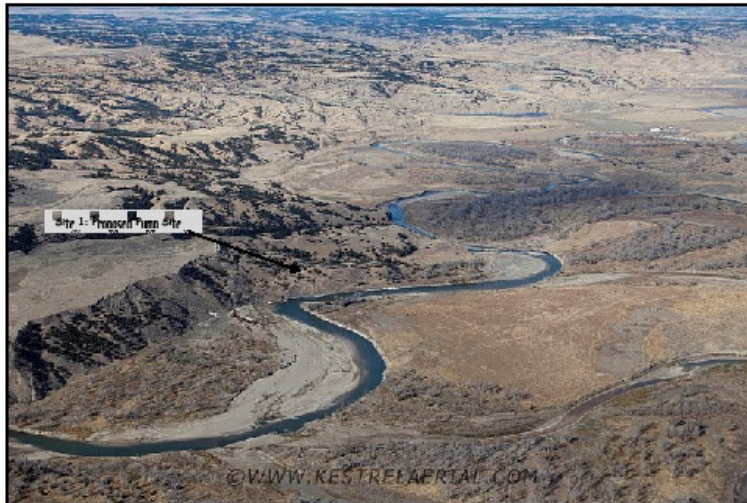
Figure 9. November 2011 photo showing Site 1 in foreground (Kestrel Aviation).

This area experienced extensive flood damages. There were multiple avulsions, bank erosion was severe, the channel widened dramatically, and fields were buried with sediment. A recent air photo of the site shows how dramatic the flood damage was, with extensive new open bar areas and abandoned cutoff channels (Figure 9 and Figure 10). The river will continue to adjust to its new configuration for many years. To that end, we recommend that flexible solutions be considered as much as possible, so project implementation and maintenance costs can be minimized in the long run.

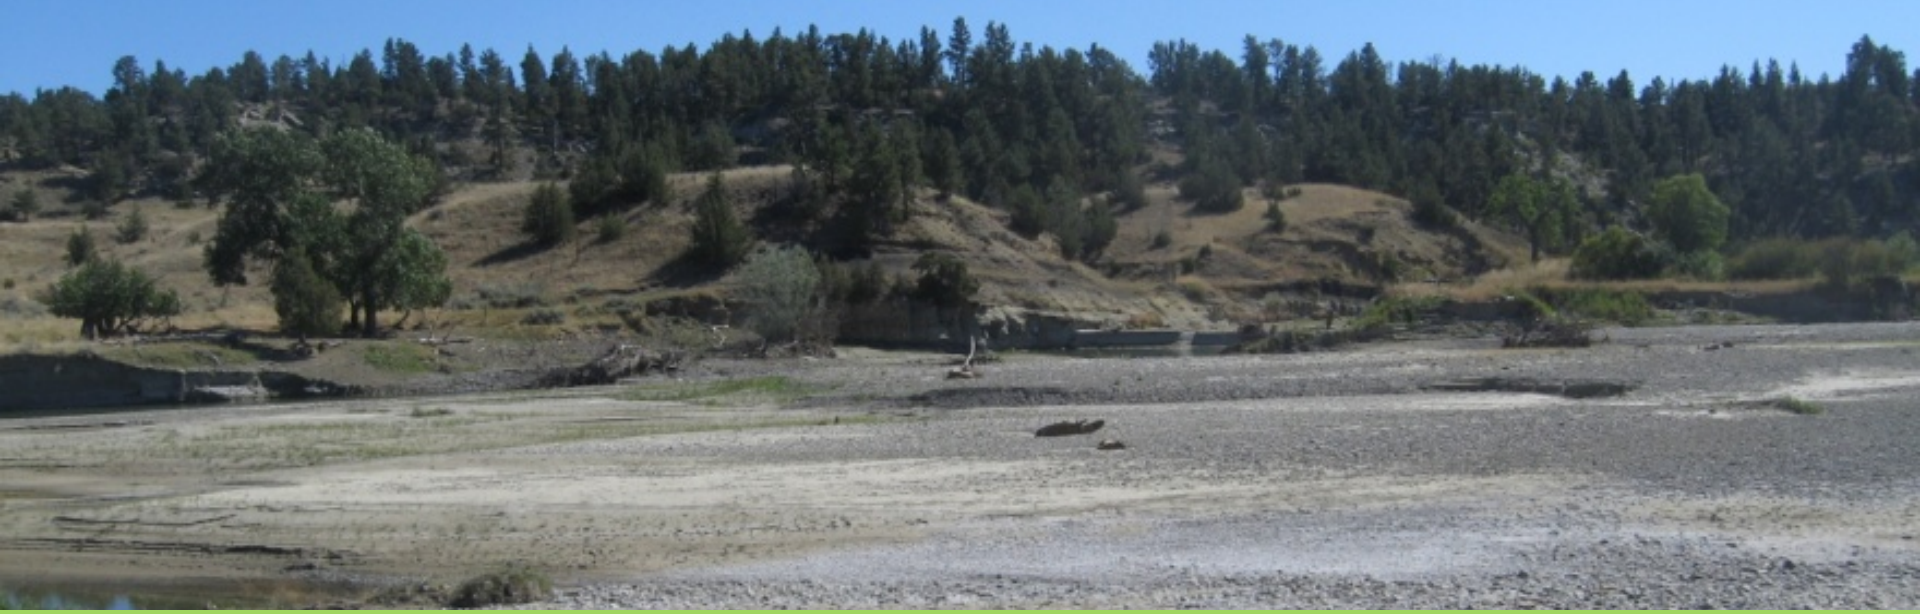
# **The new inset floodplain should improve long-term function**
